**Neutral Citation Number: [2019] EWHC 481 (Admlty)**

**(1) ALIZE 1954  
(2) CMA CGM SA**

**ALLIANZ ELEMENTAR VERSICHERUNGS AG  
AND OTHERS**

1. On 17 May 2011 the CMA CGM LIBRA, a modern (and laden) container vessel, grounded whilst leaving the port of Xiamen in China. The cost of her salvage was some US \$9.5 million and the total claim in General Average by her Owners against Cargo Interests was some US \$13 million. 92% of the Cargo Interests paid their contribution to GA but some 8% have refused to do so. The sum payable by those interests is approximately US \$800,000 and it is claimed in these proceedings. The claim has given rise to questions of unseaworthiness, due diligence, negligent navigation and causation.

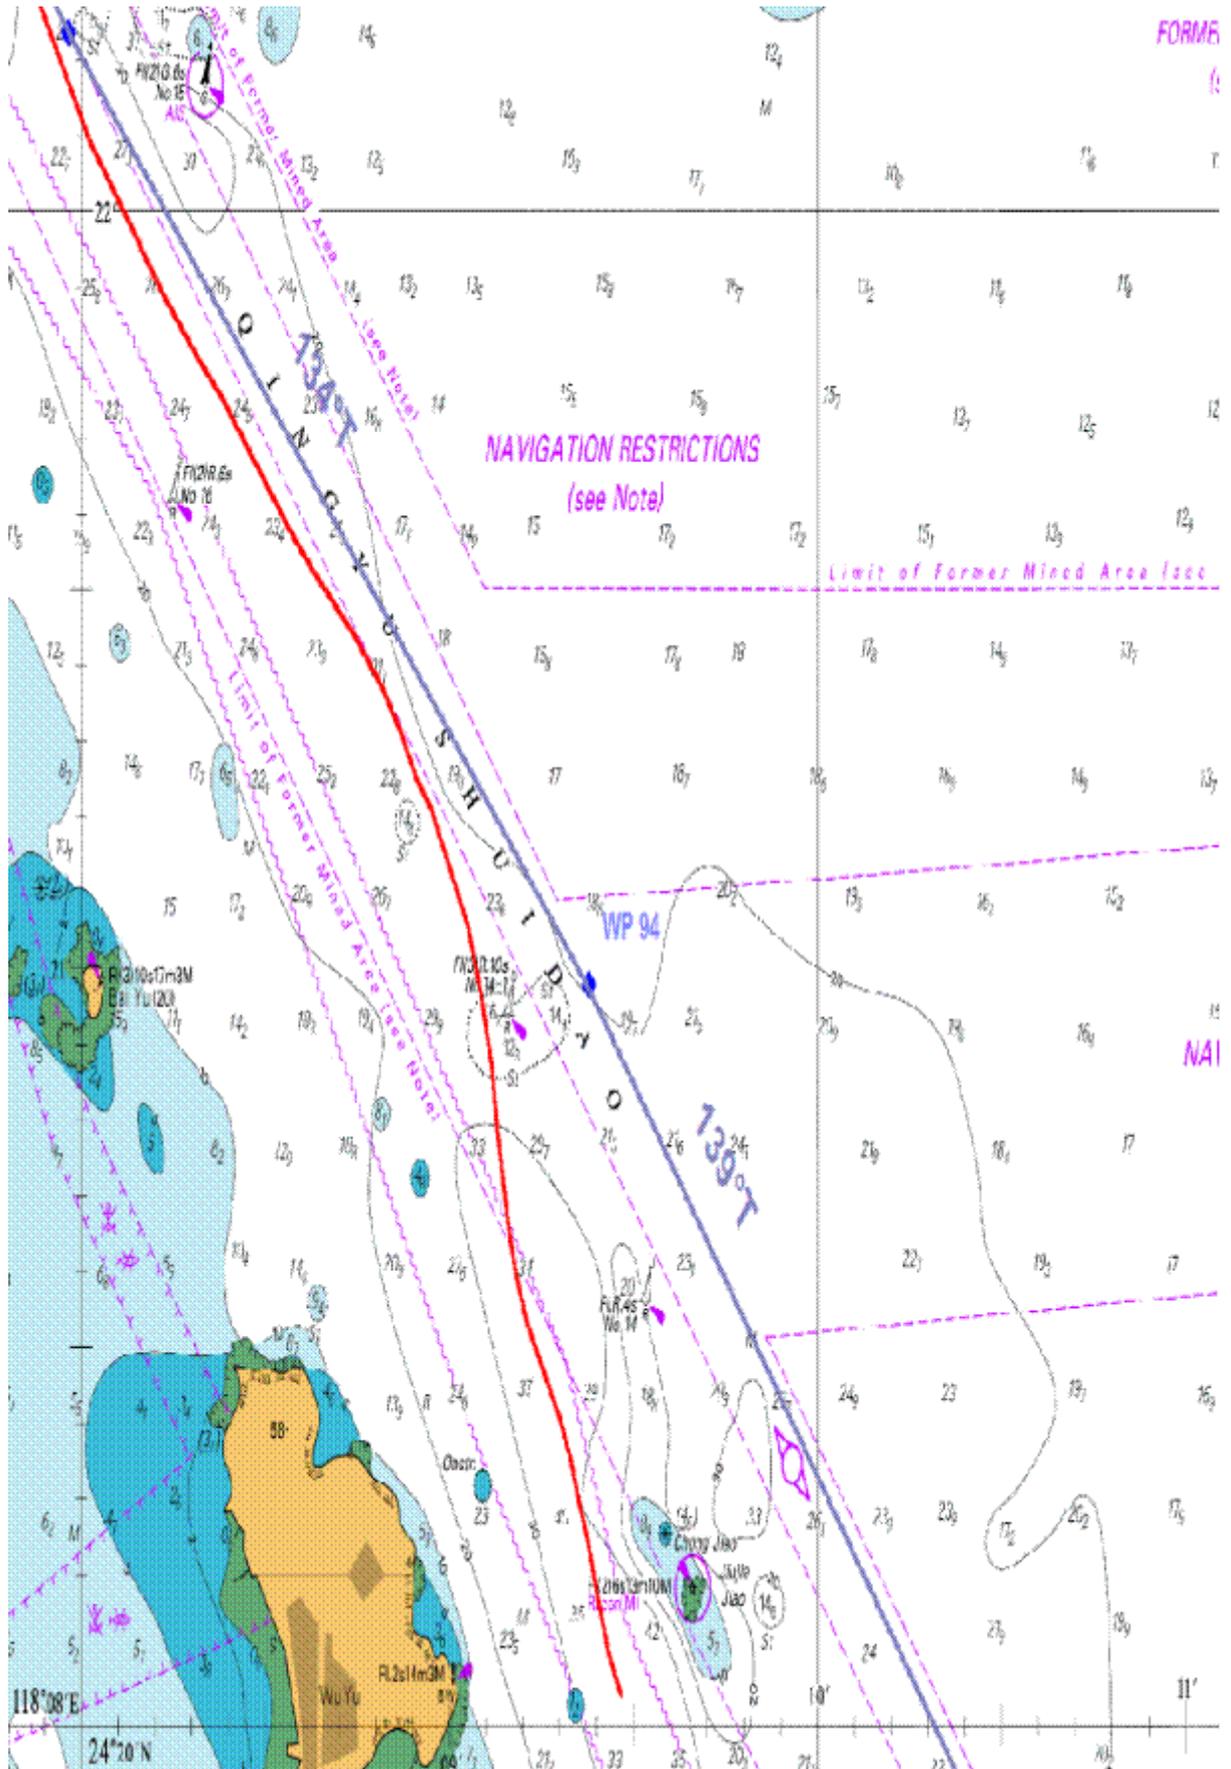
**CHART EXTRACT**

22. Shortly before 0235 on 18 May 2011 the vessel grounded whilst leaving Xiamen. She was about 4 cables to the west of the buoyed fairway in an area where there were charted depths of over 30 metres. She was between the rocks of Juijie Jiao (which were under 2 cables to the west of the buoyed channel) and the sounding of 1.2 metres newly marked on the 30 metre contour. The latter sounding was less than a cable to starboard of the vessel.

23. The paper Admiralty chart did not indicate the shoal on which the vessel grounded (though the sounding of 1.2 metres which was added to the chart in April 2011 might have been part of that shoal). However, there is evidence that the shoal on which the vessel grounded was marked on an amendment to the ENC (cell C1514291) which was issued on 13 January 2011 by the Hydrographic Office. But the vessel did not carry (and was not required by SOLAS to carry) ENC charts.
